GEOTECHNICAL INVESTIGATION REPORT OF THE PROPOSED JABULANI PRECINCT, SOWETO

Prepared for: WESPLAN AND ASSOCIATES

**Report No.: 12006
Date: JANUARY 2007**

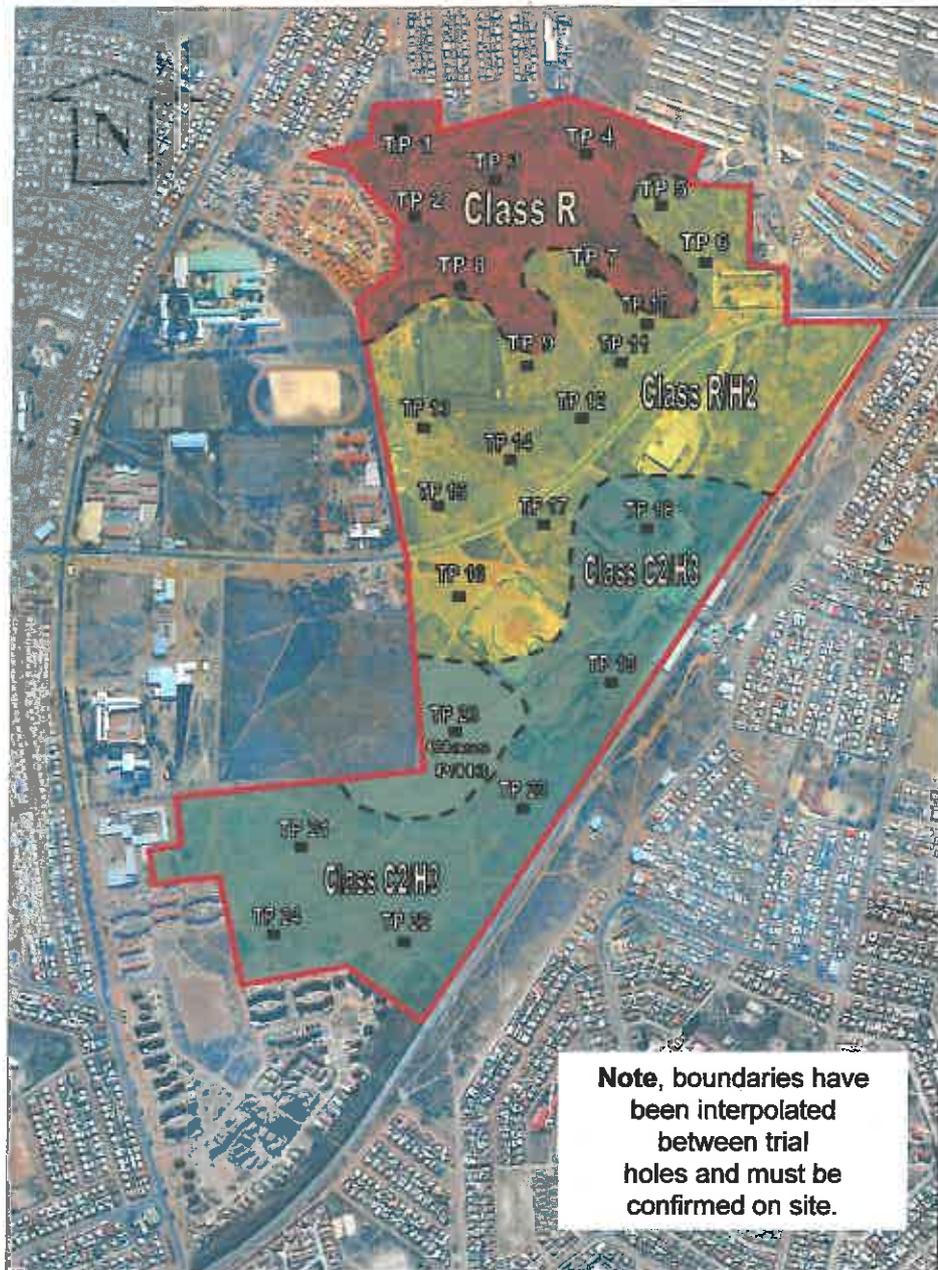
**SITE PLAN
AND
GEOLOGY MAP**

- Site Class R** Underlain by outcropping bedrock
- Site Class R/H2** Shallow bedrock and 15 to 30mm heave predicted
- Site Class C2/H3** Greater than 10mm consolidation and collapse settlement and greater than 30mm heave predicted
- Site Class P/H3** Underlain by uncontrolled fill and greater than 30mm heave predicted

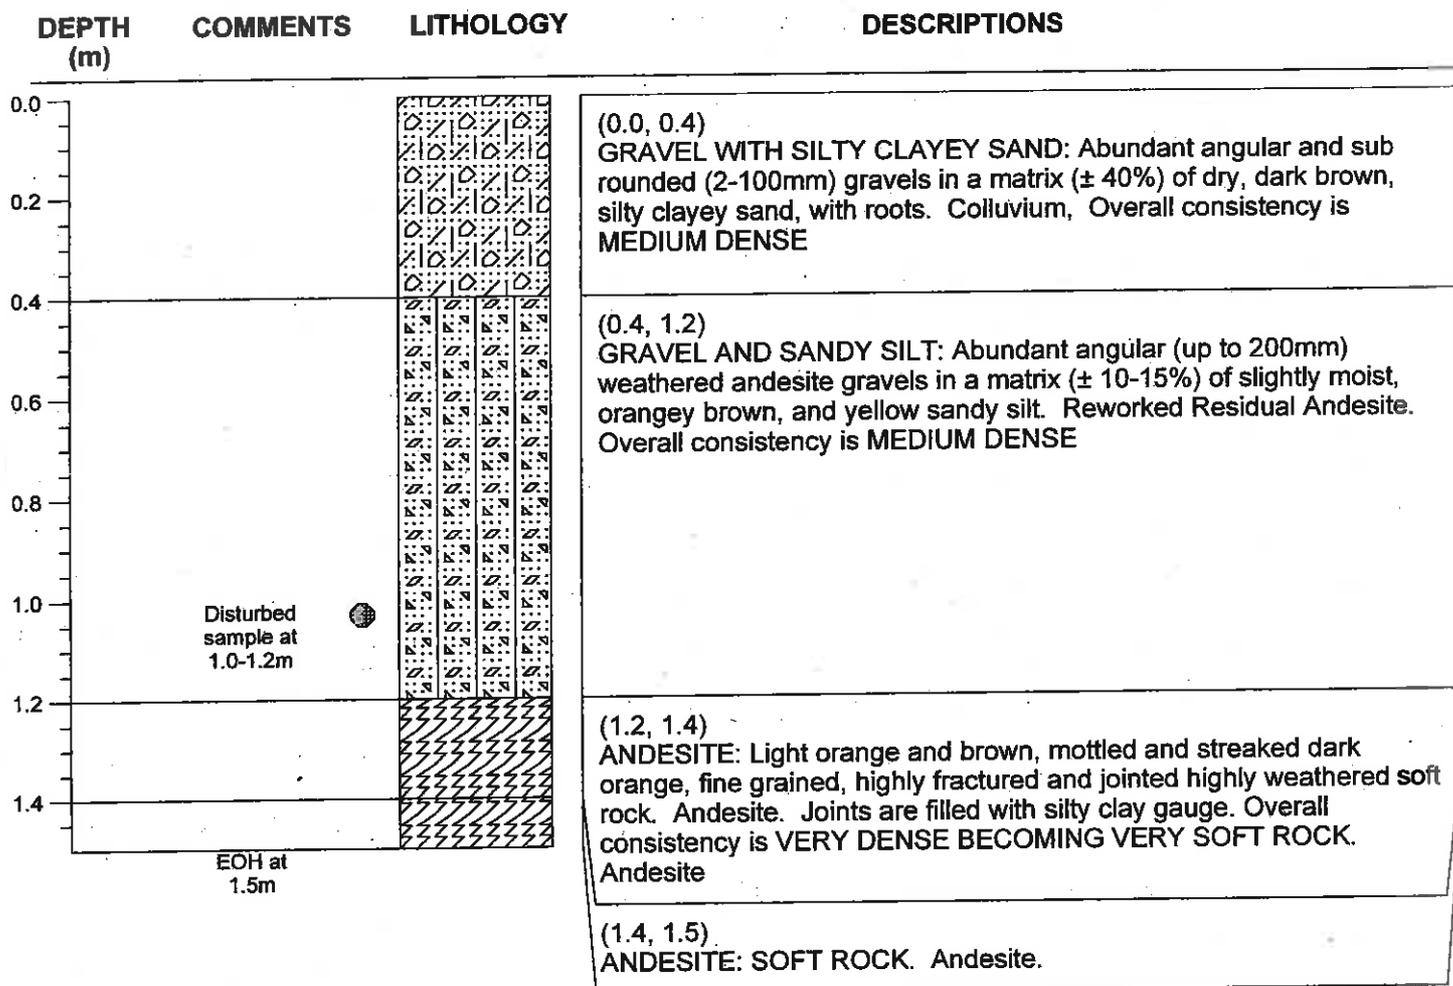
HOLE No.: TP 5

1. EOH refusal
2. No groundwater seepage
3. Disturbed sample taken at 1.0 to 1.2m

DEPTH (m)	COMMENTS	LITHOLOGY	DESCRIPTIONS
0.0			(0.0, 0.5) GRAVEL WITH SILTY CLAYEY SAND: Abundant angular and sub rounded (2-100mm) gravels in a matrix (\pm 40%) of dry, dark brown, silty clayey sand, with roots. Colluvium, Overall consistency is MEDIUM DENSE
0.2			
0.4			
0.6			(0.5, 1.4) GRAVEL AND SANDY SILT: Abundant angular (up to 200mm) weathered andesite gravels in a matrix (\pm 10-15%) of slightly moist, orangey brown, and yellow sandy silt. Reworked Residual Andesite. Overall consistency is MEDIUM DENSE
0.8			
1.0			
1.2			
1.4			(1.4, 1.7) ANDESITE: Light orange and brown, mottled and streaked dark orange, fine grained, highly fractured and jointed highly weathered soft rock. Andesite. Joints are filled with silty clay gauge. Overall consistency is VERY DENSE BECOMING VERY SOFT ROCK. Andesite
1.6			
1.8	EOH at 1.8m		(1.7, 1.8) ANDESITE: SOFT ROCK. Andesite.

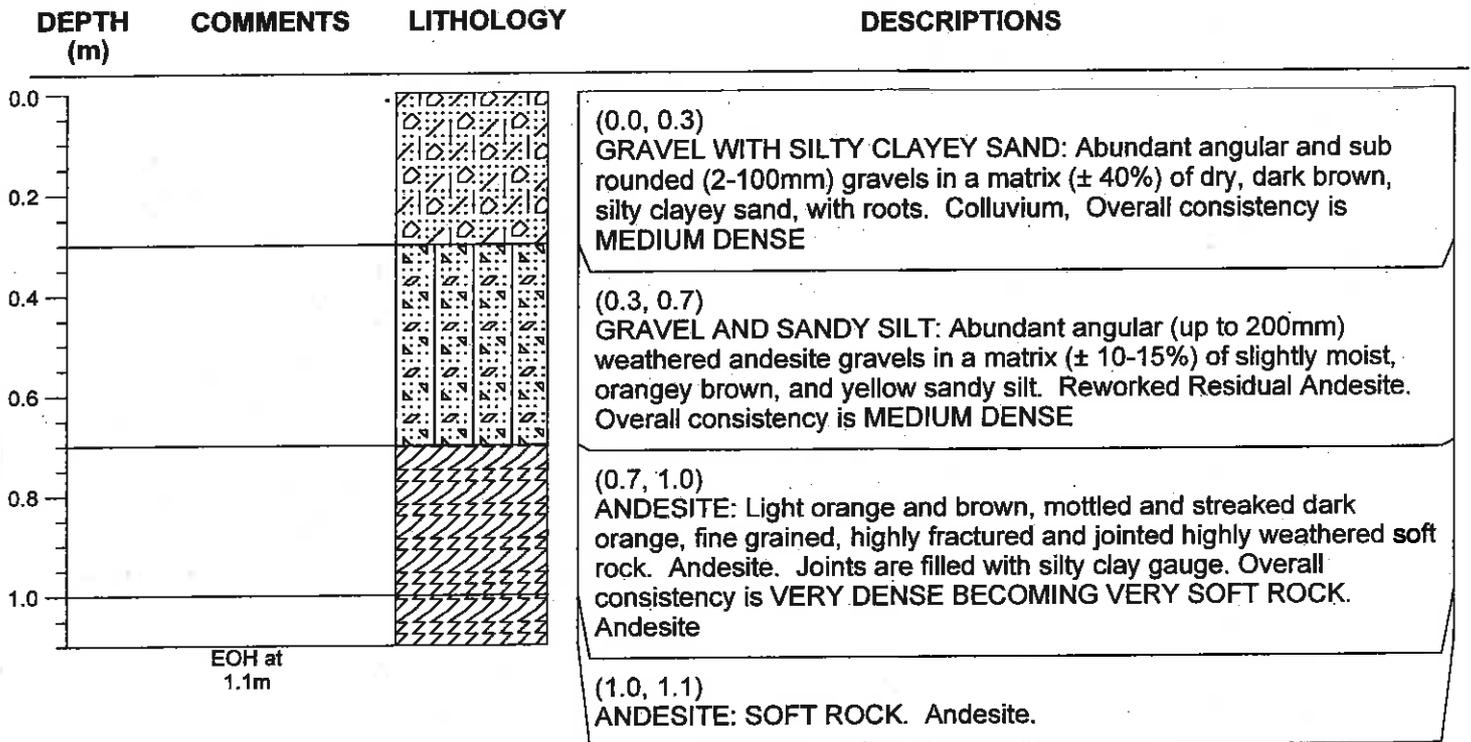
HOLE No.: TP 7

1. EOH refusal
2. No groundwater seepage
3. No samples taken

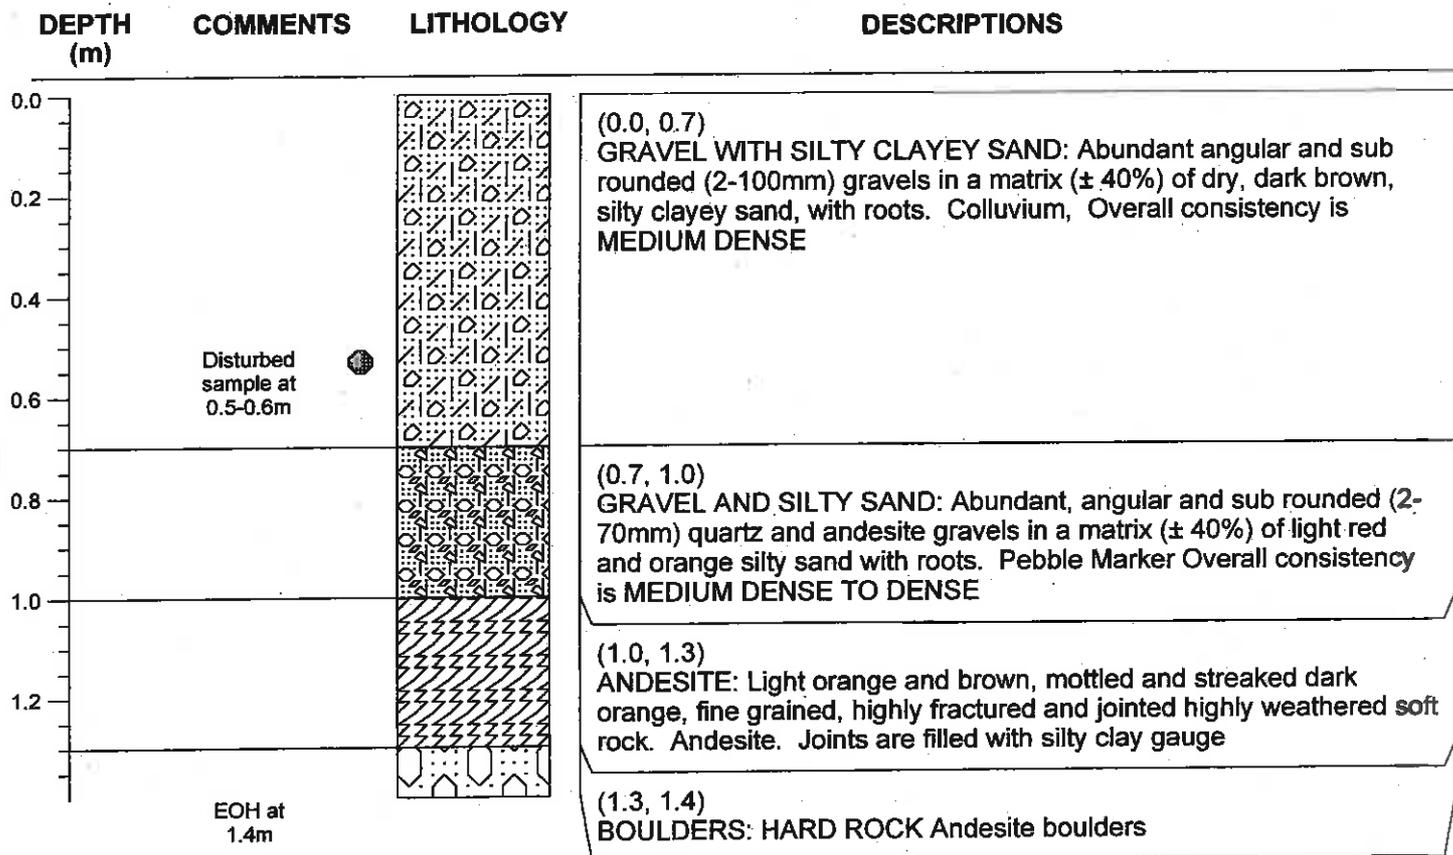
HOLE No.: TP 8

1. EOH refusal on boulders
2. No groundwater seepage
3. Disturbed sample taken at 0.5 to 0.6m

0.6			
0.8			
1.0			(0.5, 1.3) GRAVEL AND SANDY SILT: Abundant angular (up to 200mm) weathered andesite gravels in a matrix ($\pm 10-15\%$) of slightly moist, orangey brown, and yellow sandy silt. Reworked Residual Andesite. Overall consistency is DENSE

1.2			
1.4			(1.3, 1.6) ANDESITE: Light orange and brown, mottled and streaked dark orange, fine grained, highly fractured and jointed highly weathered soft rock. Andesite. Joints are filled with silty clay gauge. Overall consistency is VERY DENSE TO VERY SOFT ROCK. Andesite

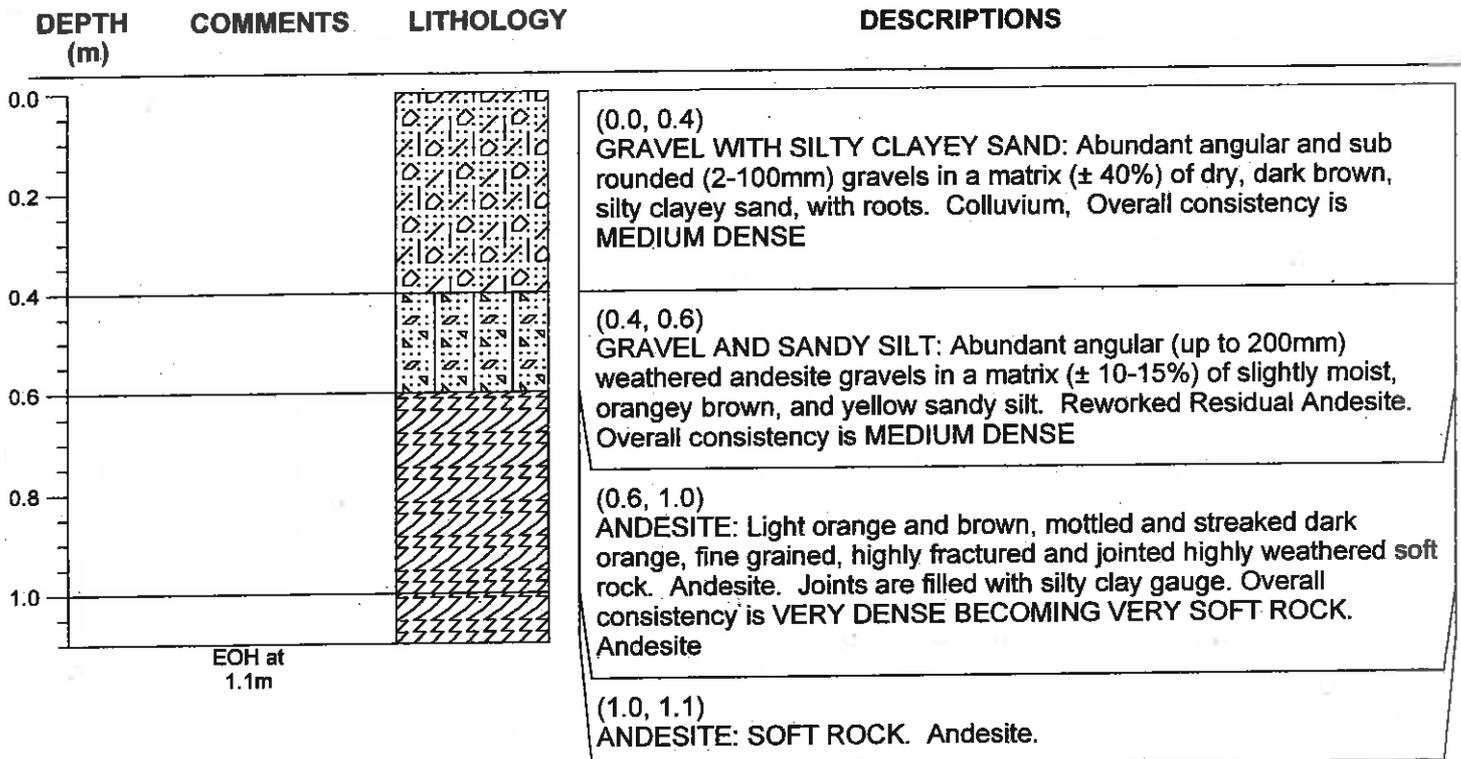
HOLE No.: TP 10

1. EOH refusal
2. No groundwater seepage
3. No samples taken

0.4			(0.6, 1.0) GRAVEL AND SANDY SILT: Abundant angular (up to 200mm) weathered andesite gravels in a matrix ($\pm 10-15\%$) of slightly moist, orangey brown, and yellow sandy silt. Reworked Residual Andesite. Overall consistency is DENSE

0.6			(1.0, 1.3) ANDESITE: Light orange and brown, mottled and streaked dark orange, fine grained, highly fractured and jointed highly weathered soft rock. Andesite. Joints are filled with silty clay gauge

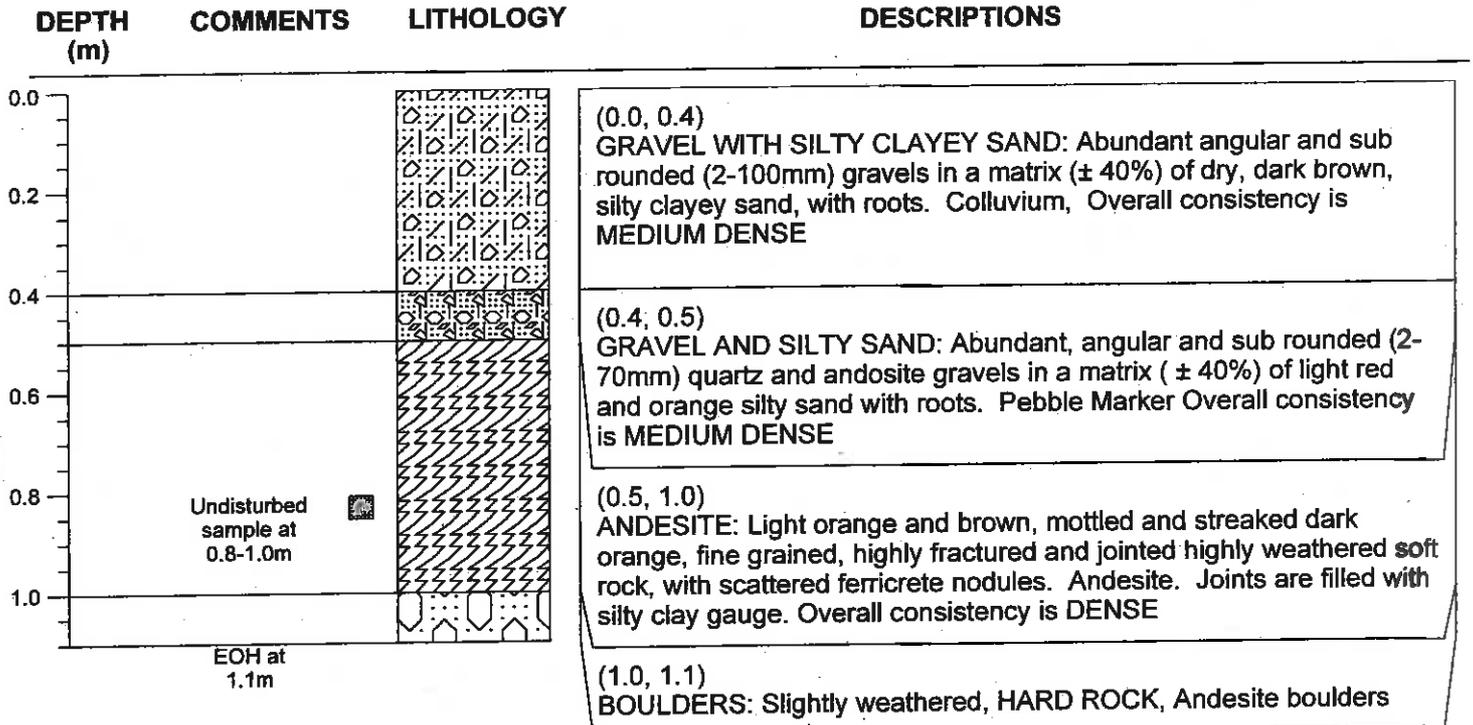
HOLE No.: TP 12

1. EOH refusal
2. No groundwater seepage
3. Undisturbed sample taken at 0.8 to 1.0m

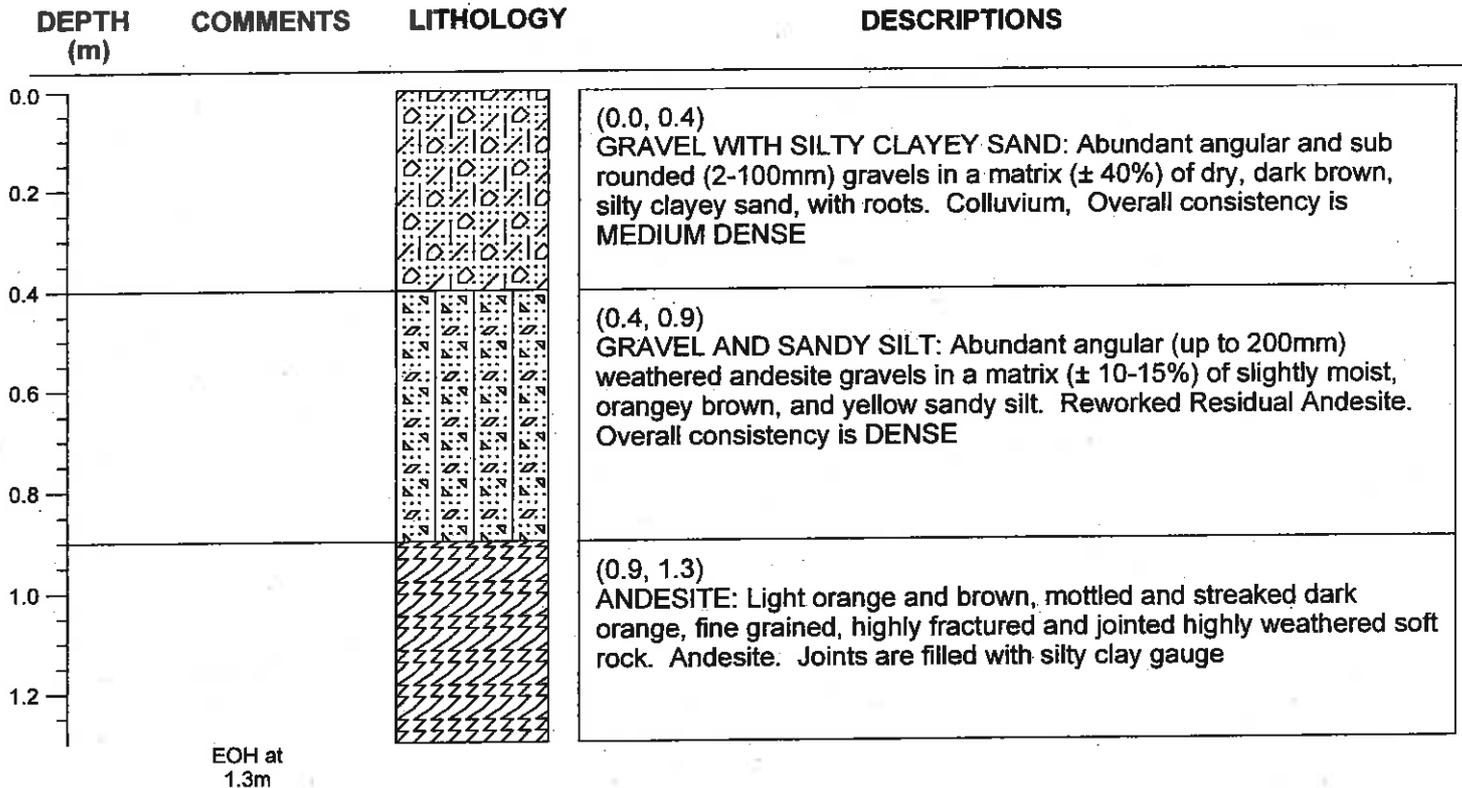
HOLE No.: TP 16

1. EOH refusal
2. No groundwater seepage
3. No samples taken

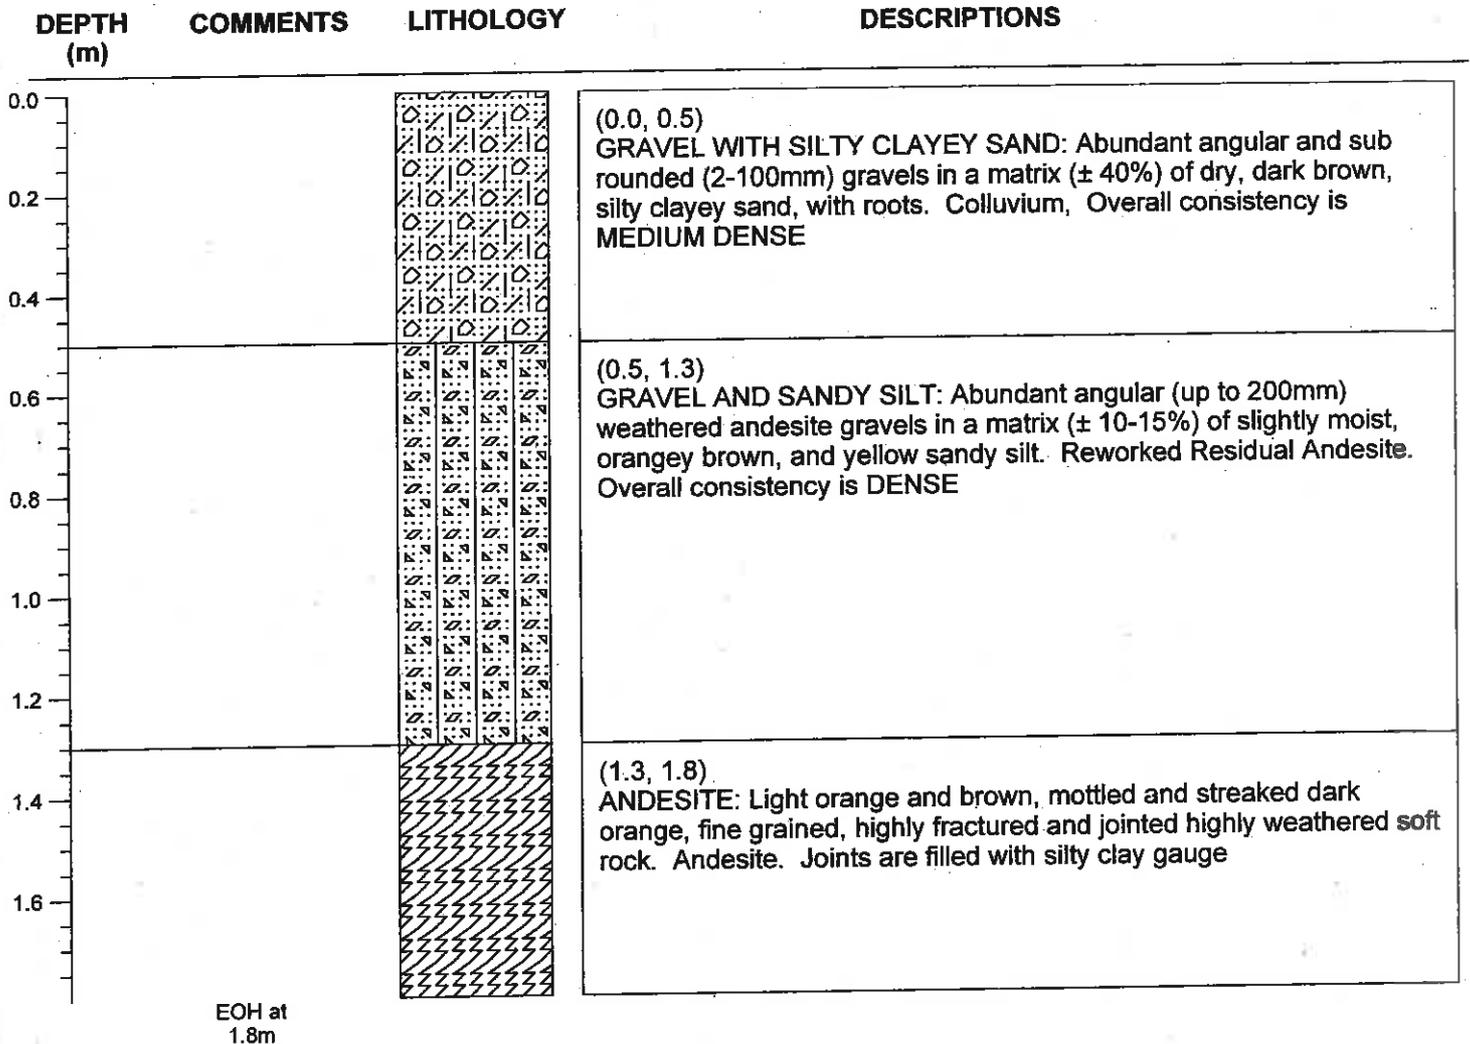
HOLE No.: TP 15

1. EOH refusal
2. No groundwater seepage
3. No samples taken

DEPTH (m)	COMMENTS	LITHOLOGY	DESCRIPTIONS
0.0			(0.0, 0.6) GRAVEL WITH SILTY CLAYEY SAND: Abundant angular and sub rounded (2-100mm) gravels in a matrix (\pm 40%) of dry, dark brown, silty clayey sand, with roots. Colluvium, Overall consistency is MEDIUM DENSE .
0.2			
0.4			
0.6			(0.6, 1.7) GRAVEL AND SANDY SILT: Abundant angular (up to 200mm) weathered andesite gravels in a matrix (\pm 10-15%) of slightly moist, orangey brown, and yellow sandy silt. Reworked Residual Andesite. Overall consistency is DENSE .
0.8			
1.0			
1.2			
1.4			
1.6			
1.7			(1.7, 1.8) ANDESITE: Light orange and brown, mottled and streaked dark orange, fine grained, highly fractured and jointed highly weathered soft rock. Andesite. Joints are filled with silty clay gauge
1.8			(1.8, 1.9) ANDESITE: SOFT ROCK. Andesite

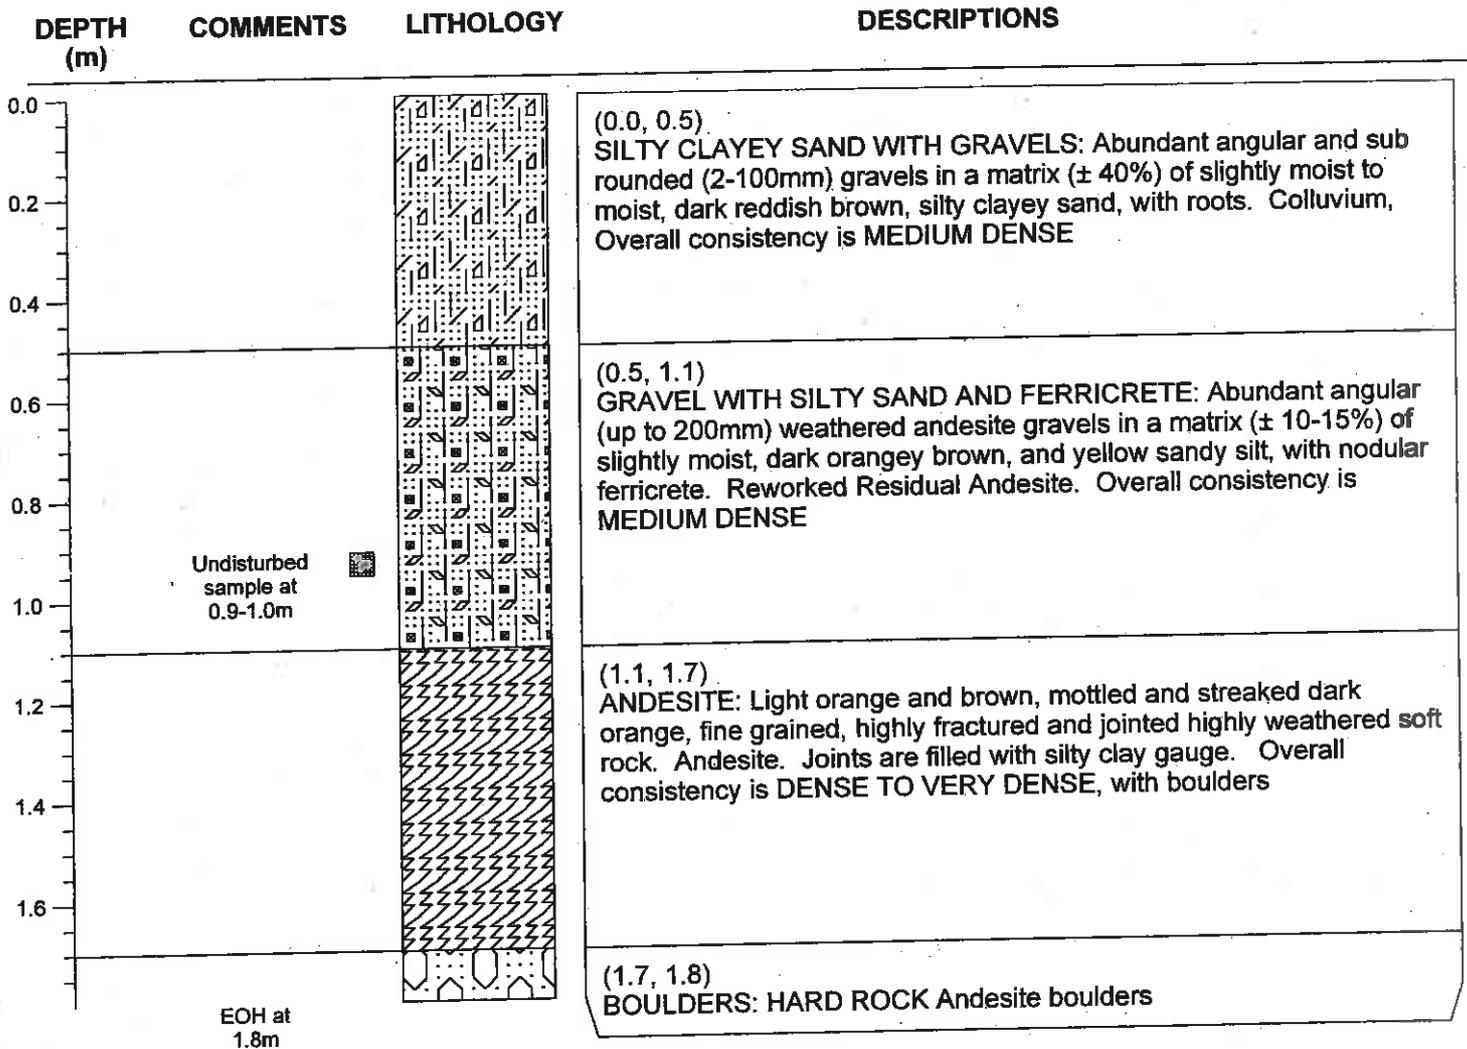
HOLE No.: TP 18

1. EOH refusal on boulders
2. No groundwater seepage
3. Undisturbed sample taken at 0.9 to 1.0m
4. Extensive termite activity

DEPTH (m)	COMMENTS	LITHOLOGY	DESCRIPTIONS
0.0			(0.0, 0.5) GRAVEL WITH SILTY CLAYEY SAND: Abundant angular and sub rounded (2-100mm) gravels in a matrix ($\pm 40\%$) of dry, dark brown, silty clayey sand, with roots. Colluvium, Overall consistency is MEDIUM DENSE
0.2			
0.4			
0.5			(0.5, 1.3) GRAVEL AND SANDY SILT: Abundant angular (up to 200mm) weathered andesite gravels in a matrix ($\pm 10-15\%$) of slightly moist, orangey brown, and yellow sandy silt. Reworked Residual Andesite. Overall consistency is DENSE
0.6			
0.8			
1.0			
1.2			
1.3			(1.3, 1.6) ANDESITE: Light orange and brown, mottled and streaked dark orange, fine grained, highly fractured and jointed highly weathered soft rock. Andesite. Joints are filled with silty clay gauge
1.4			
1.6			(1.6, 1.7) ANDESITE: SOFT ROCK, Andesite

Termite activity was noted on the site and it is therefore recommended that a recognised, environmentally acceptable pesticide/insecticide be used to combat the threat of ants/termites and rodents to the integrity of the foundations.

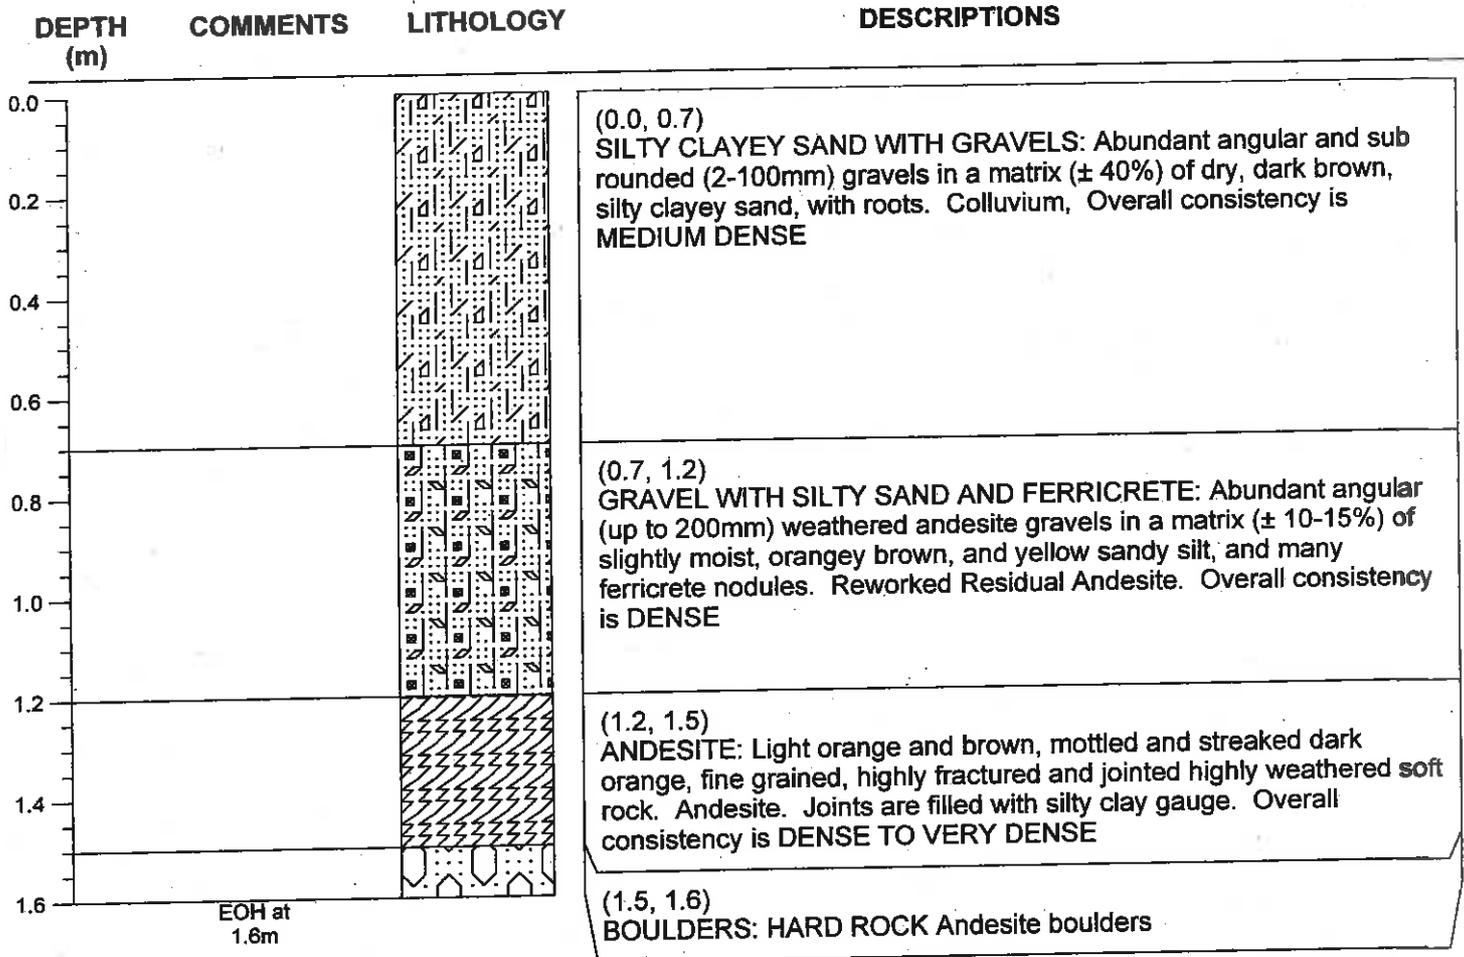
HOLE No.: TP 20

1. EOH refusal on boulders
2. No groundwater seepage
3. No samples taken

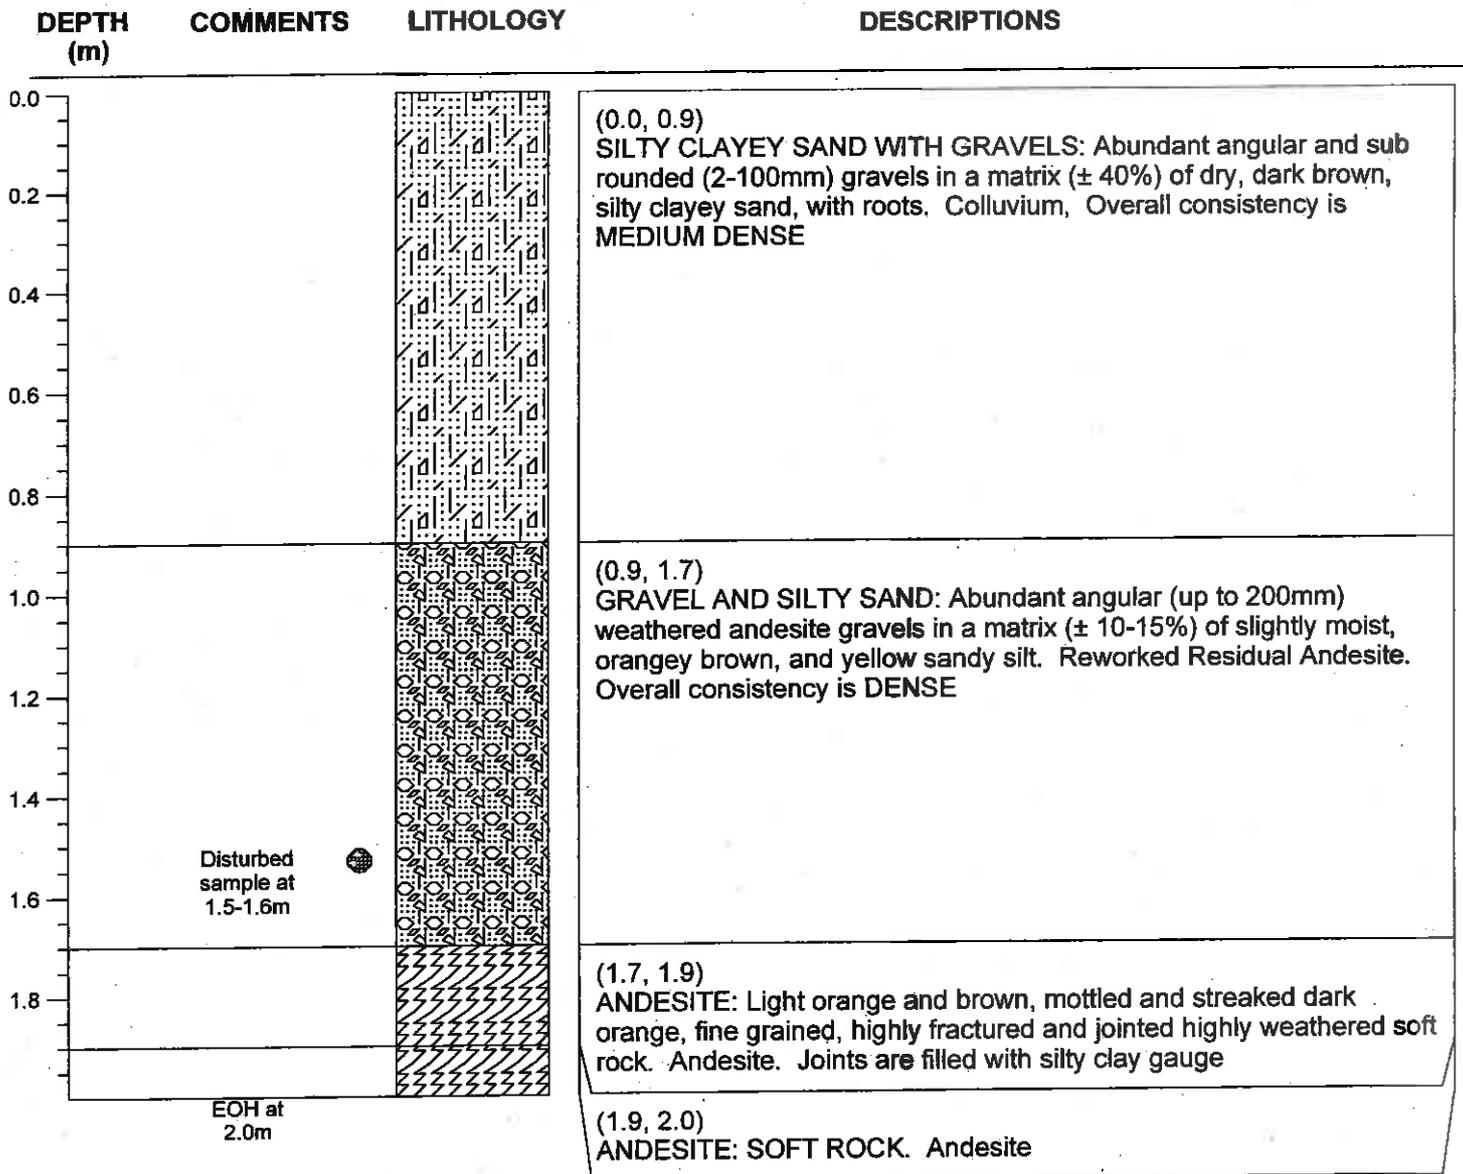
HOLE No.: TP 21

1. EOH refusal
2. No groundwater seepage
3. Disturbed sample taken at 1.5 to 1.6m

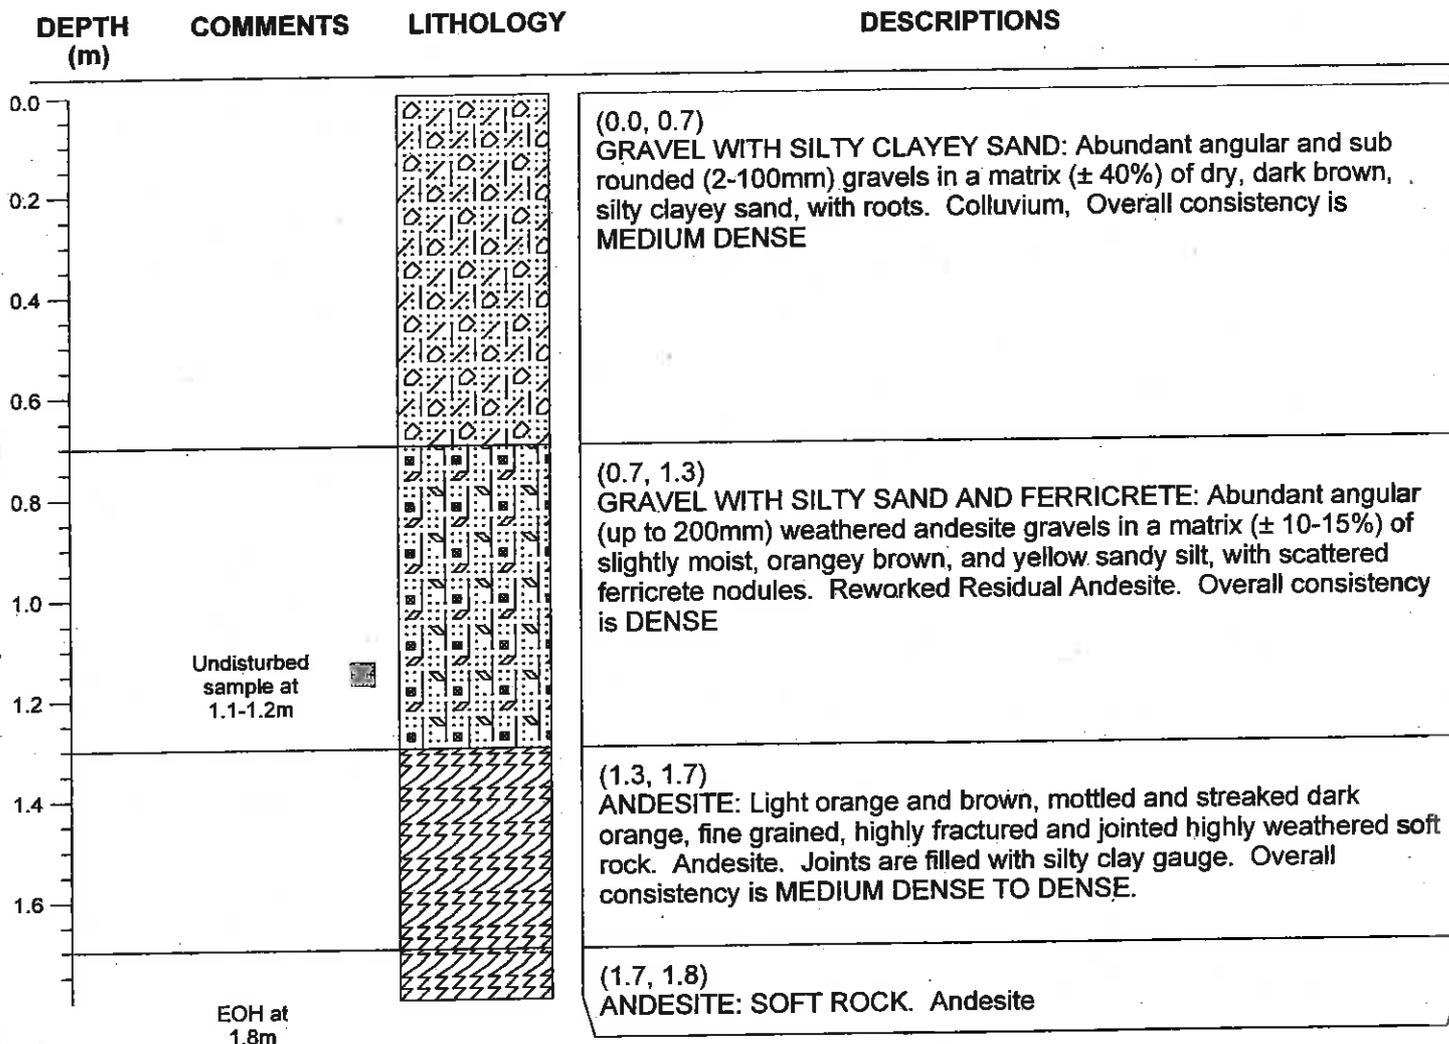
HOLE No.: TP 22

1. EOH hard dig
2. No groundwater seepage
3. Undisturbed sample taken at 1.1 to 1.2m

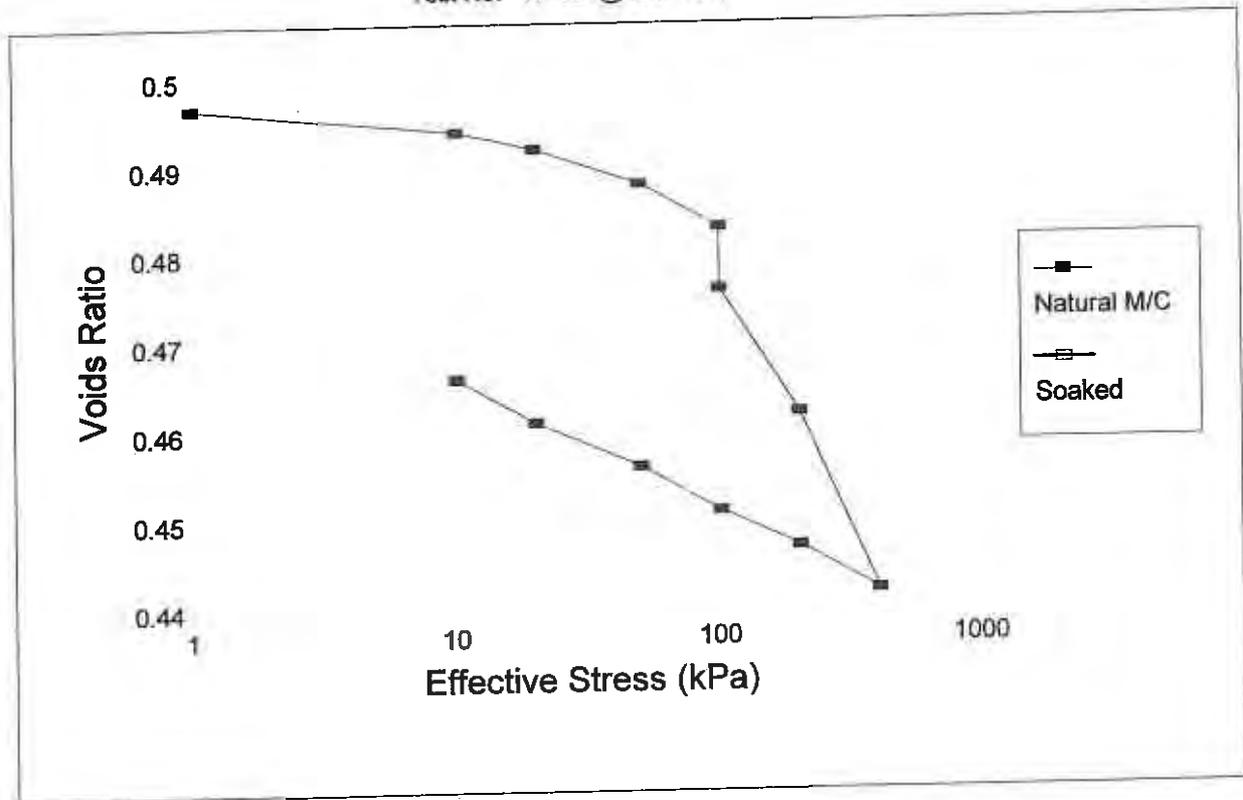
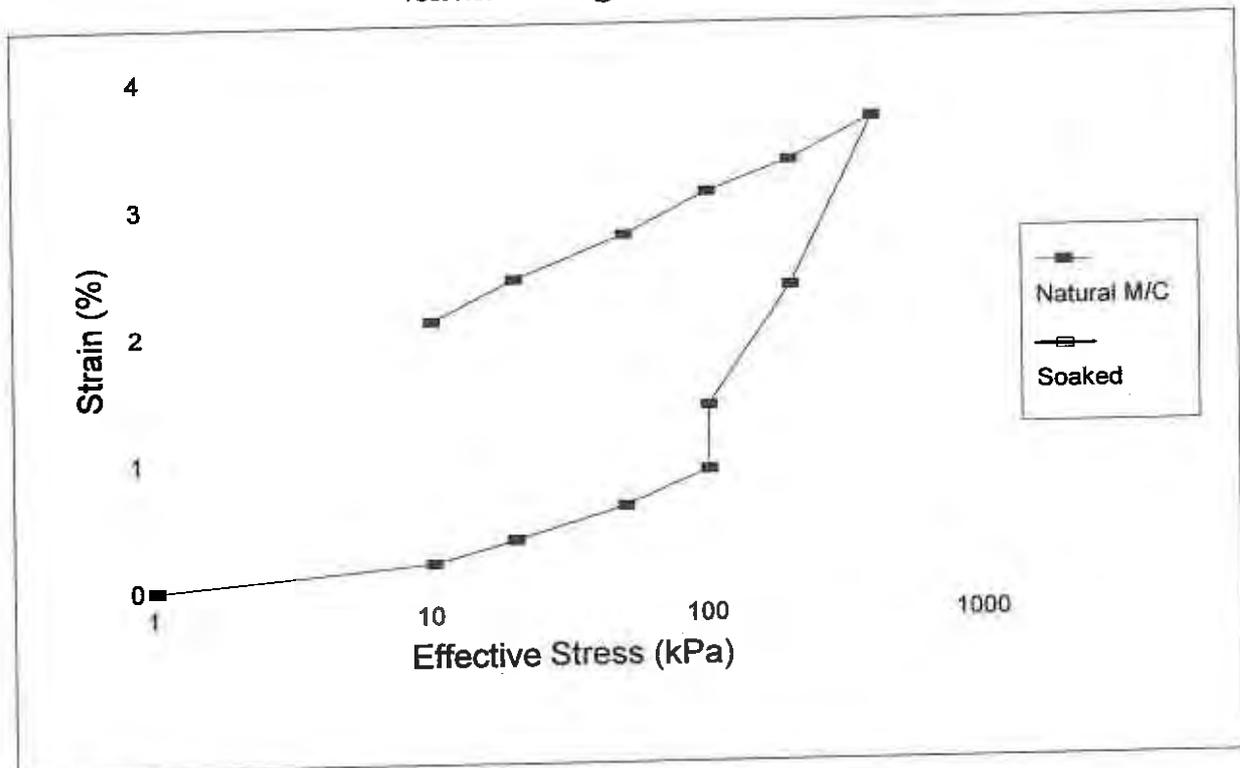
Test No: TP 12 @ 0.8-1.0m

Mass wet sample plus ring before test (gms)	278.80
Mass wet sample plus ring after test (gms)	296.00
Mass dry sample plus ring (gms)	271.60
Mass ring (gms)	119.70
Moisture content before test (%)	4.74
Moisture content after test (%)	16.06

The Consolidation test completed on the residual andesite indicated that these soils are compressible and slightly collapsible. The magnitudes of the anticipated settlements are shown in table 3 below. These values have been calculated by assuming that 700mm wide strip footings will be placed at an average depth of 0.7m below natural ground surface and the foundations would apply a bearing pressure of 100kPa.

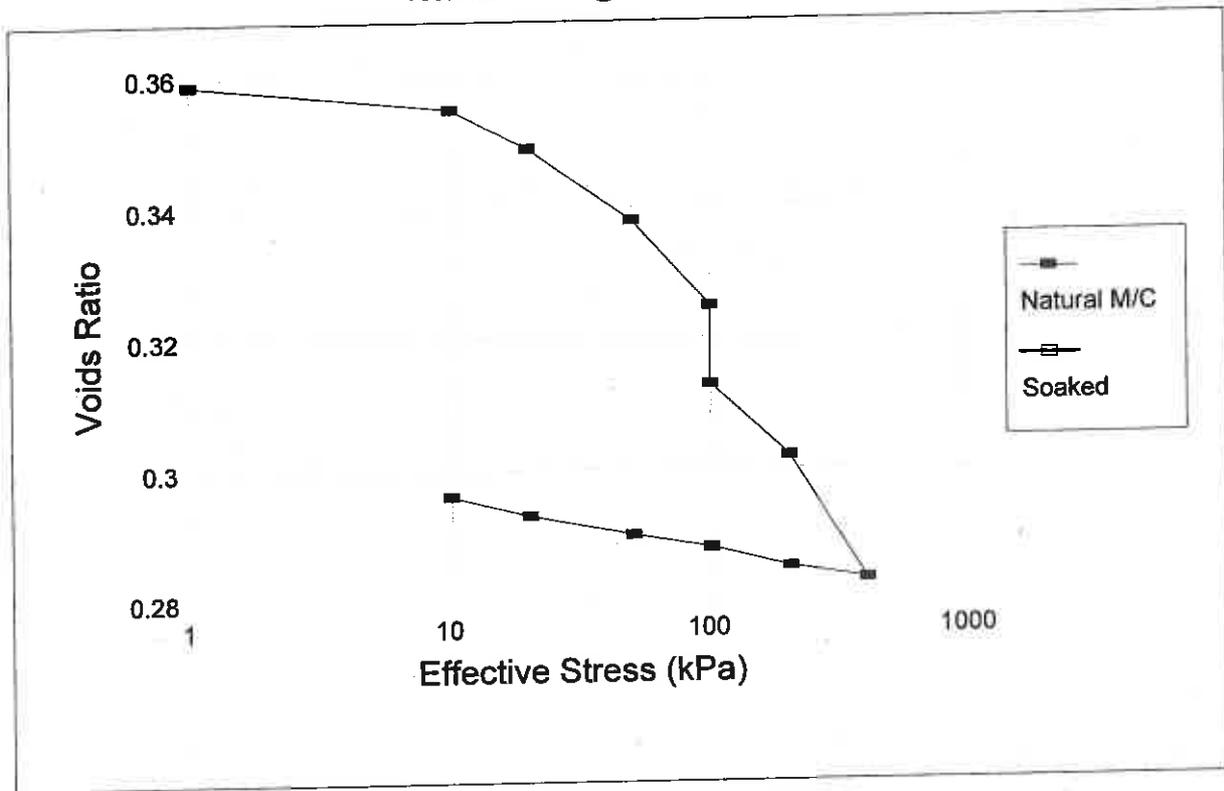
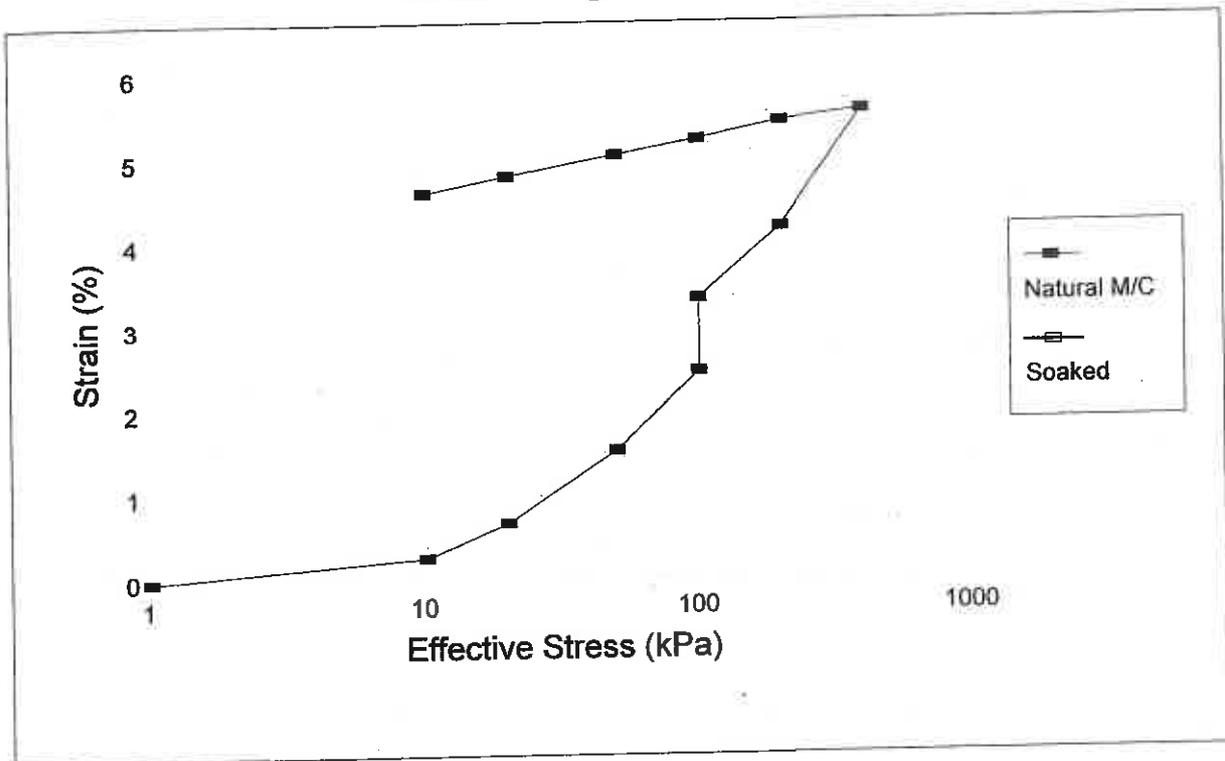
Test No: TP 18 @ 0.9-1.0m

Mass wet sample plus ring before test (gms)	298.60
Mass wet sample plus ring after test (gms)	301.10
Mass dry sample plus ring (gms)	282.60
Mass ring (gms)	116.10
Moisture content before test (%)	9.61
Moisture content after test (%)	11.11
