GEOTECHNICAL INVESTIGATION REPORT OF THE PROPOSED JABULANI PRECINCT, SOWETO

Prepared for: WESPLAN AND ASSOCIATES

**Report No.: 12006
Date: JANUARY 2007**

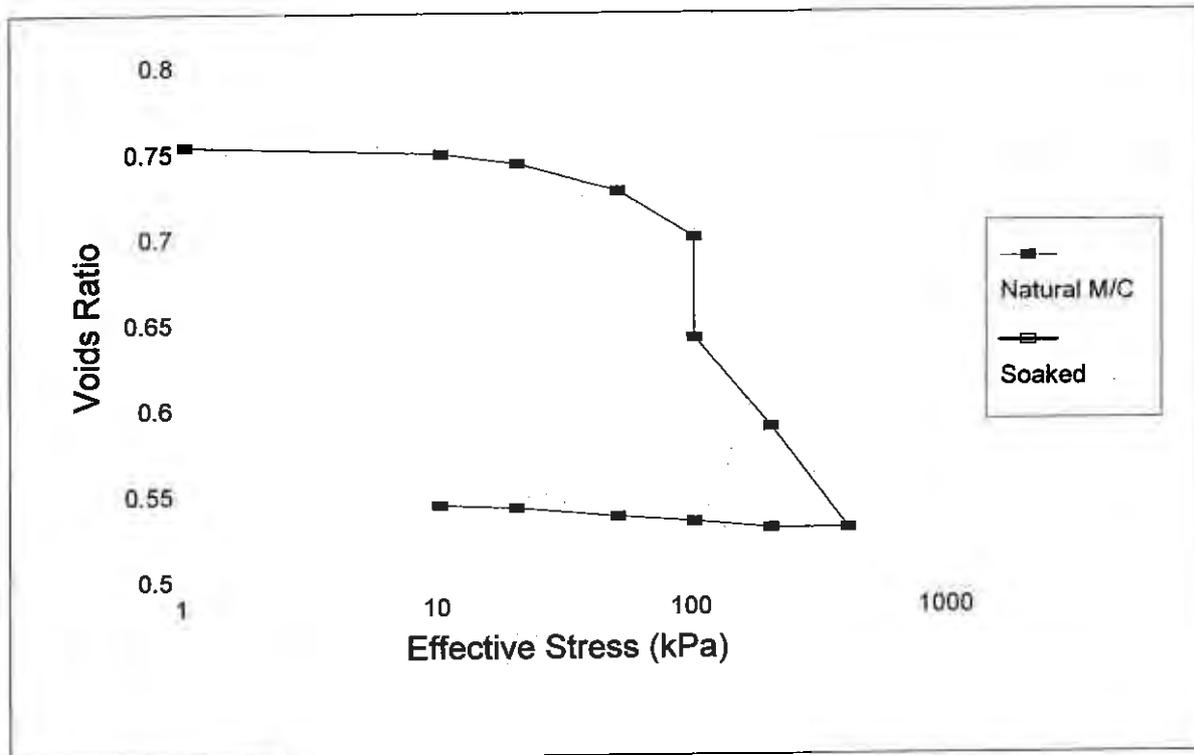
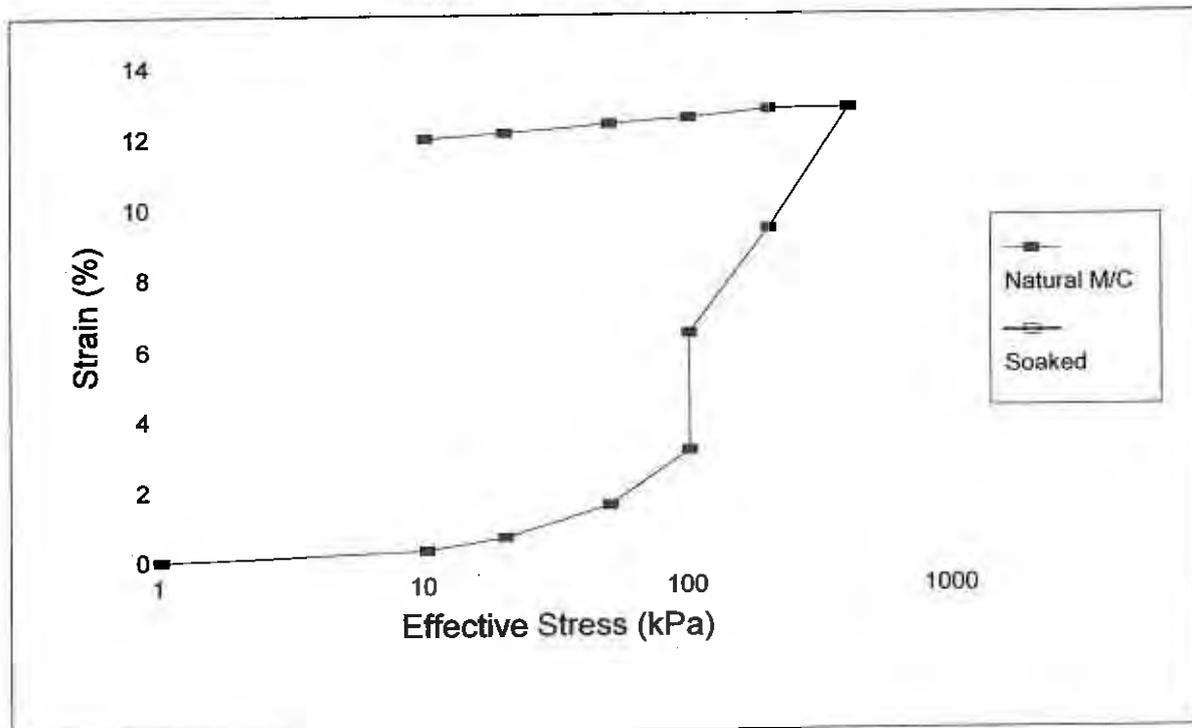
Test No: TP 22 @ 1.1-1.2m

Mass wet sample plus ring before test (gms)	221.40
Mass wet sample plus ring after test (gms)	227.50
Mass dry sample plus ring (gms)	204.70
Mass ring (gms)	92.70
Moisture content before test (%)	14.91
Moisture content after test (%)	20.36

The Consolidation test completed on the residual andesite indicated that these soils are compressible and slightly collapsible. The magnitudes of the anticipated settlements are shown in table 3 below. These values have been calculated by assuming that 700mm wide strip footings will be placed at an average depth of 0.7m below natural ground surface and the foundations would apply a bearing pressure of 100kPa.
